# CAFO FACILITY INSPECTION REPORT

<u>8365996001</u> WDID NUMBER	<u>Bud Bosch</u> OWNER NAME	<u>Bosch Dairy No. 2</u> FACILITY NAME
<u>CAG018001</u> NPDES NUMBER	<u>Ex. 6 Personal Privacy (PP)</u> OWNER ADDRESS	
<u>R8-2007-0001</u> RWQCB ORDER NO.	<u>Ontario, CA 91710</u> OWNER CITY AND STATE	<u>Ontario, CA 91761</u> FACILITY CITY AND STATE
<u>03/06/2013</u> SCHEDULED INSPECTION DATE	<u>Bud Bosch</u> OWNER CONTACT	<u>Bud Bosch</u> FACILITY CONTACT
<u>03/06/2013</u> ACTUAL INSPECTION DATE	<u>Ex. 6 Personal Privacy (PP)</u> OWNER PHONE NO.	
<u>Unknown</u> RECEIVING WATER	<u>Ex. 6 Personal Privacy (PP)</u> FACILITY PHONE NO.	
	<u>Ex. 6 Personal Privacy (PP)</u> FACILITY LATITUDE	<u>Ex. 6 Personal Privacy (PP)</u> FACILITY LONGITUDE

On March 6, 2013, a Concentrated Animal Feeding Operation (CAFO) inspection was conducted for Santa Ana Water Board Order No. R8-2007-0001 - 'General Waste Discharge Requirements for Concentrated Animal Feeding Operations (Dairies and Related Facilities) within the Santa Ana Region', NPDES General Permit No. (CAG018001) at Bosch Dairy No. 2 in Ontario, California (refer to Photo 1). The inspectors spoke with Mr. Bud Bosch (Owner, Bosch Dairy No. 2) at appr

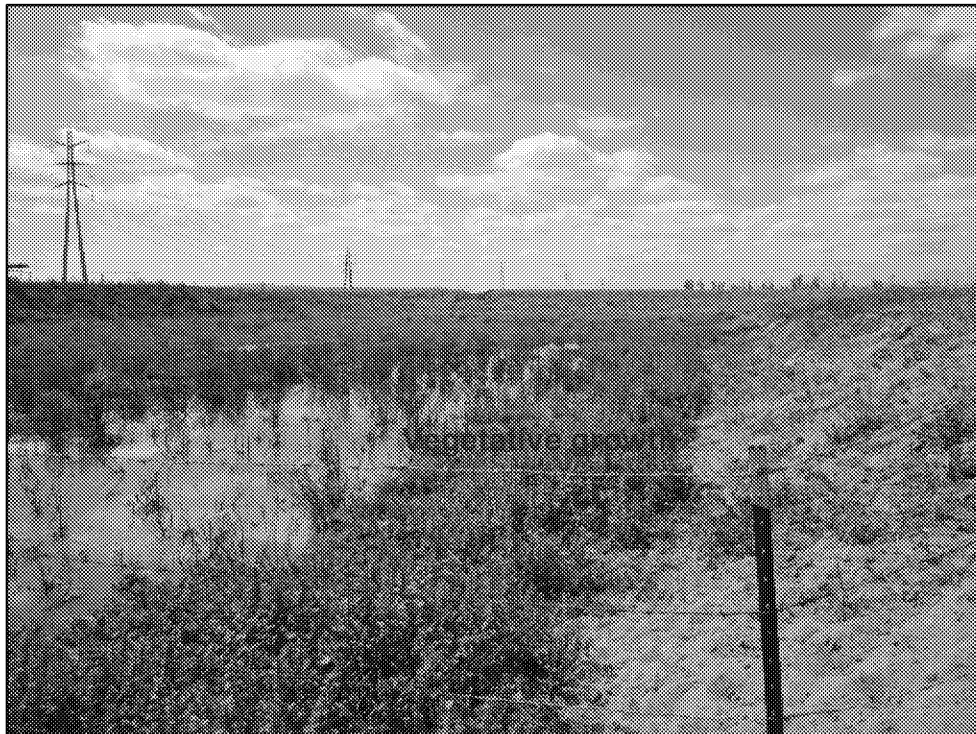
3. Vegetative growth was observed in the wastewater containment pond at the Facility (refer to Photos 2 and 3). The Discharger must maintain all containment structures to contain all wastewater within the Facility, including all process wastewater and all precipitation on, and drainage through, manured areas from rainfall up to and including a 25-year, 24-hour rainfall event, as required by Provision VII.C.3.a of the Permit.

2. The inspector observed, during the inspection, vegetative growth potentially diminishing the wastewater containment pond capacity (refer to Photos 2 and 3). Section 5.8, 'Operation and Maintenance Plan', of the approved EWMP states "The ponding and disposal areas should be kept free of weeds and any other excess vegetation that may decrease the capacity of containment facilities, or inhibit the ability to access any berms or containment areas." As a result, the overall capacity of the containment structure at the Facility may be diminished. The Discharger must maintain all containment structures to contain all wastewater within the Facility, including all process wastewater and all precipitation on, and drainage through, manured areas from rainfall up to and including a 25-year, 24-hour rainfall event, as required by Provision VII.C.3.a of the Permit.

**Photograph 2.** View facing west of the vegetative growth in the process wastewater containment pond located adjacent to the southern perimeter of the Facility.

1. Verify that the EWMP is retained onsite and available for review
2. Verify that the EWMP is fully implemented (e.g., daily inspections)
3. Verify that weekly and daily Storm Water Management Structure visual inspections are being conducted and documented
4. Verify that excessive vegetative growth is kept free of the process wastewater containment pond and disposal fields to ensure adequate capacity of the containment facilities
5. Verify that Annual Reports for the previous (5) five years are retained

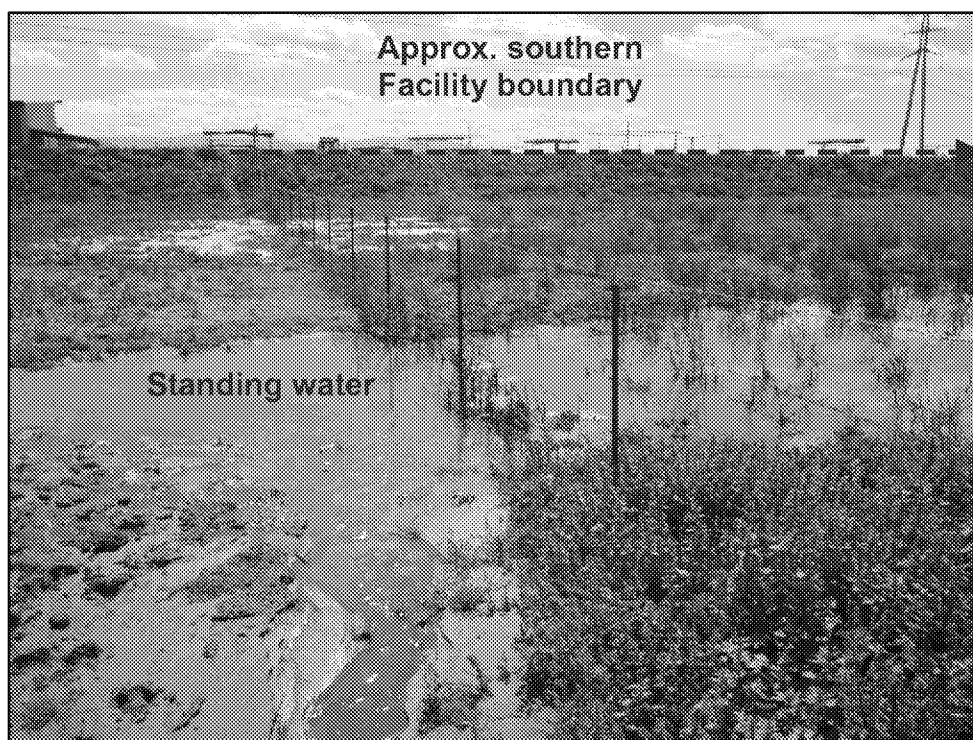
**Photograph 3.** View facing south of the vegetative growth and standing water in the process wastewater containment pond located adjacent to the southern perimeter of the Facility.

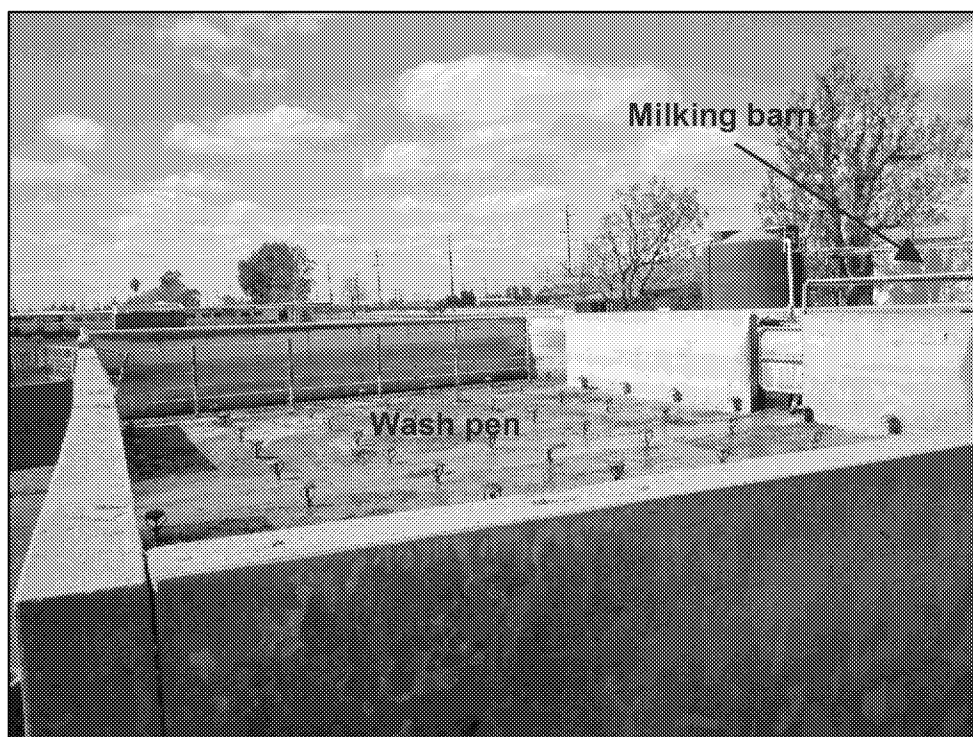
**Photograph 4.** View facing northwest of wash pen prior to the milking barn. Note process wastewater from the wash pen and milking barn are piped to the disposal field, shown in Photographs 6 and 7.

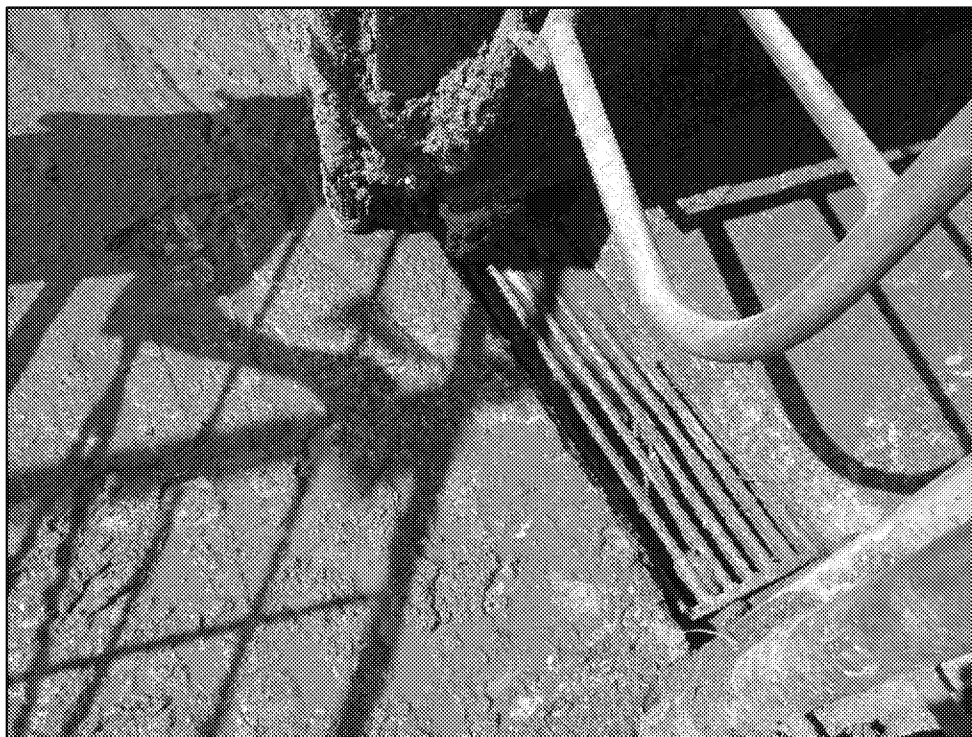
**Photograph 5.** Close-up view of process wastewater drain inlet which collects process wastewater from the wash pen, shown in Photograph 4, and then conveys the wastewater to the alfalfa valves and disposal field, shown in Photograph 6.

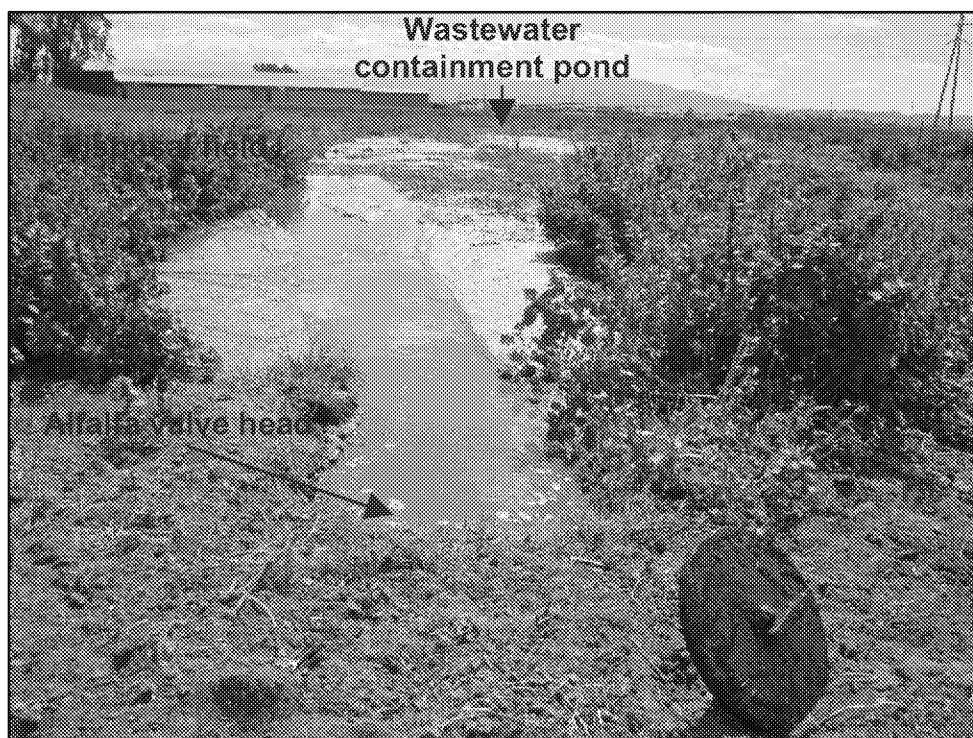
**Photograph 6.** View facing south of process wastewater being land applied to the disposal field via alfalfa valve head upgradient of the wastewater containment pond, shown in Photograph 2.

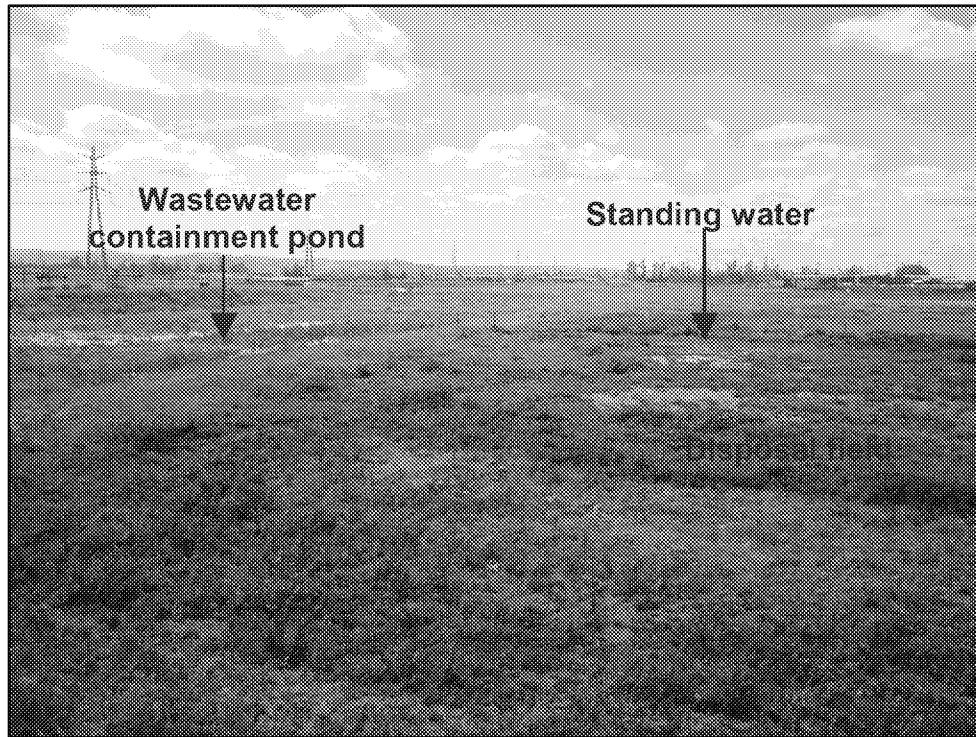
**Photograph 7.** View facing southwest of the process wastewater disposal field and containment pond located in the southern portion of the Facility. Note standing water was observed in the containment pond and disposal field at the time of the inspection.

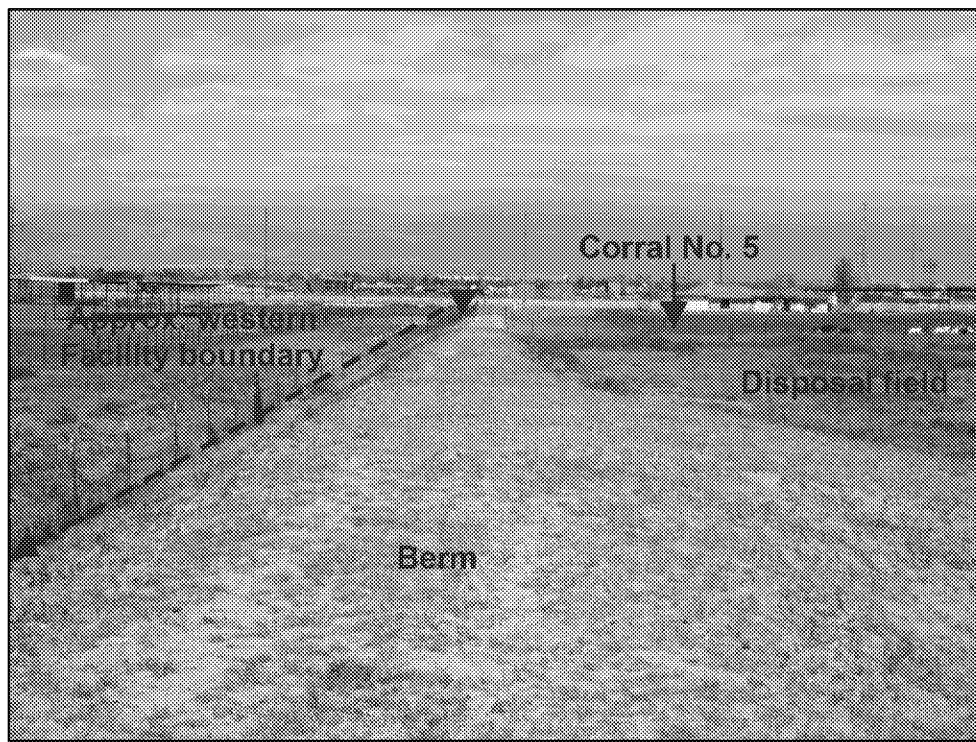
**Photograph 8.** View facing north along western Facility boundary. Note surface runoff from the corral areas drains south toward the process wastewater disposal field.

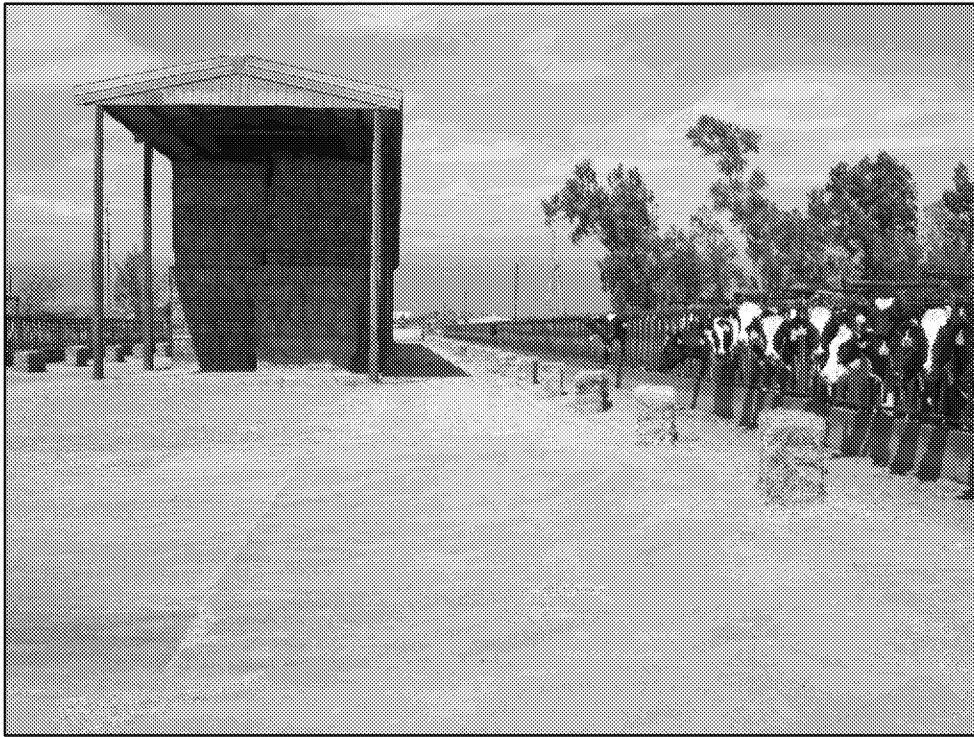
1. The Facility conditions observed at Bosch Dairy No. 2, generally indicated adequate housekeeping and pollution prevention practices. For example, the feed lanes and commodity barn located in the central portion of the Facility exhibited general good housekeeping and pollution prevention practices. (refer to Photo 9).

**Photograph 9.** View facing north of feed lanes and commodity barn located in the central portion of the Facility. Note the feed lanes and overall Facility exhibited general good housekeeping and pollution prevention practices.
